Manhole Inspection Summary

Manhole # S41C2_004MH

Location Address: **3900 10th St**

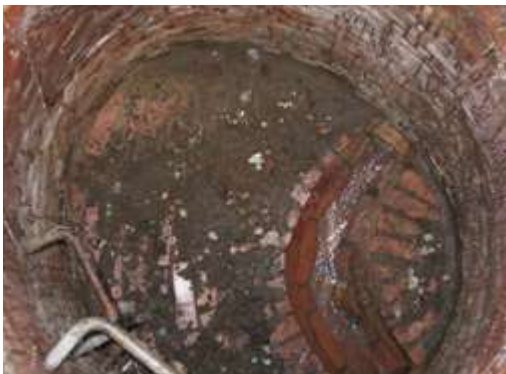
Defect 2

Debris

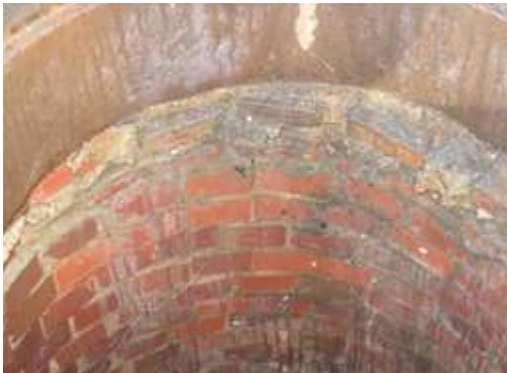
Defect 1

Infiltration: ☐ None ☐ Joint ☐ Cracks ☒ Mortar ☐ Roots ☒ Wall

Infiltration: ☐ None ☐ Joint ☐ Cracks ☒ Mortar ☐ Roots ☐ Wall

Mortar

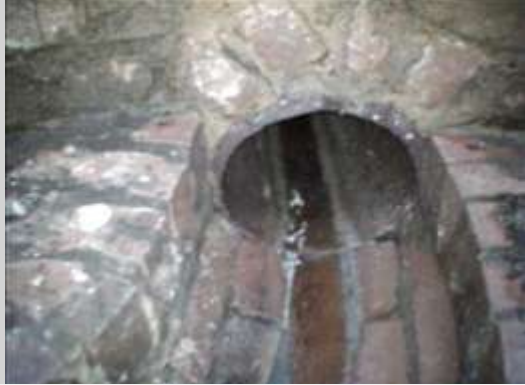
12 O'Clock Outflow

8 in. Circular Gravity Sewer
Pipe Out @ 12 O'Clock

Pipe Height: **9.6** (in.) Rod and Bar (Angled)
Pipe Material: **Clay** ☐ Pipe Lined
Invert Depth: **8.18** (ft.) Flow Characteristics: **None**
Deposits: ☒ None ☐ Mud ☐ Sludge ☐ Debris ☐ Grease
Silt Depth: (in.) Deposits Extent:
Infiltration: **None** Pipe Seal Cond: **Sound**

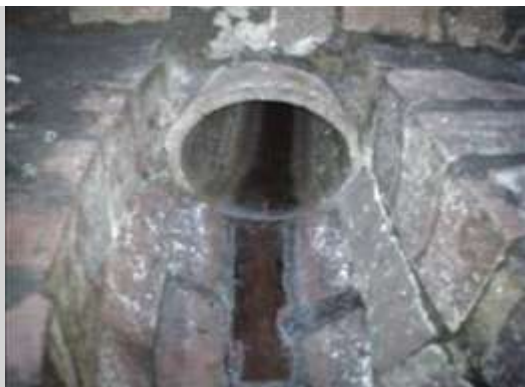
9 O'Clock Inflow

6 in. Circular Service Sewer
Pipe In @ 9 O'Clock

Pipe Height: **7.2** (in.) Rod and Bar (Angled)
Pipe Material: **Clay** ☐ Pipe Lined
Invert Depth: **7.94** (ft.) Flow Characteristics: **Fast**
Deposits: ☒ None ☐ Mud ☐ Sludge ☐ Debris ☐ Grease
Silt Depth: (in.) Deposits Extent:
Infiltration: **None** Pipe Seal Cond: **Sound**
